Dow Building & Construction

Case Study:

STYROFOAM™ Brand Insulation: Shrinkage Case Studies

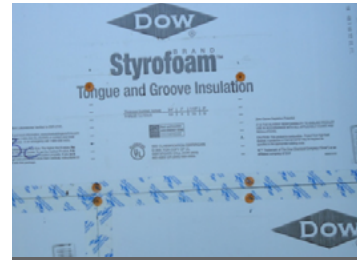
Photo 2b
Aged E Wall Assembly Sept 2015

Careful inspection of the before and after assembly photos shows similar spacing. It is clear from these photos that no opening of board joints has occurred during this test exposure period. The construction tape was still strongly adhered to the foam boards with no evidence of loss of adhesion performance through this five year period.

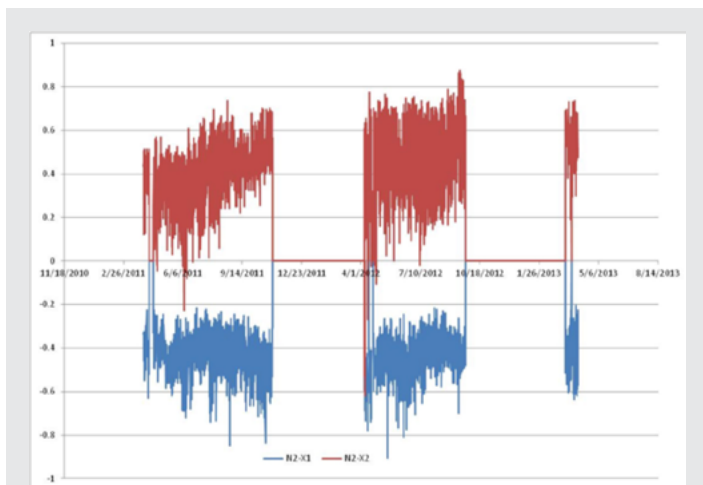
Figure 2. Length move of North elevation 2nd floor foam board

An example of board length movement relative to the building structure reference bracket is shown in Figure 2. Displacement is measured in millimeters. An increasing value for displacement indicates an increase in distance between the sensor and the reference bracket and indicates shrinkage of the board length. Since the X-direction sensors are oriented on opposite ends of the insulation board, both sensor values simultaneously increasing would indicate opposite board ends becoming closer together and the foam insulation board shrinking. These conditions are not observed in the monitored data at any of the six building locations and the maximum movement range is approximately 0.5 mm.

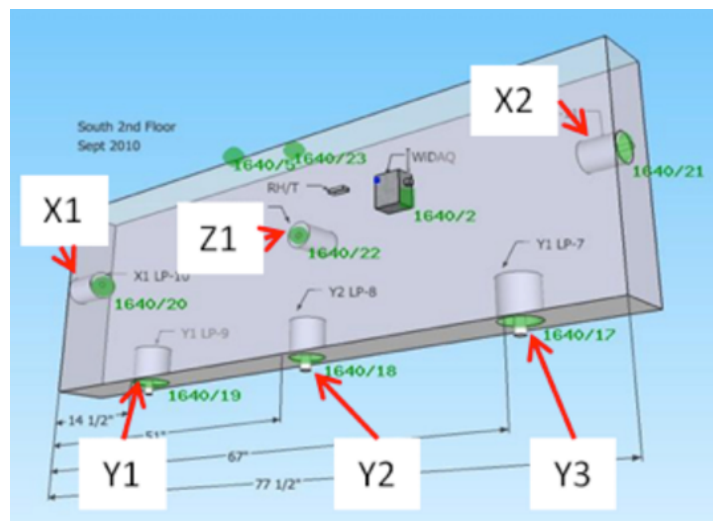
Figure 3, Sensor locations on foam board

The sensors were installed along foam board joints to monitor foam displacement relative to the structural steel of the building via an external bracket directly attached to the interior steel studs. Sensor locations on an insulation board are shown in Figure 3. This attachment facilitated foam movement relative to the steel structure to be measured. To monitor shrinkage, each panel included two side sensors (X axis). Position data was collected every two hours and transmitted via wireless data acquisition units to the network analysis software.

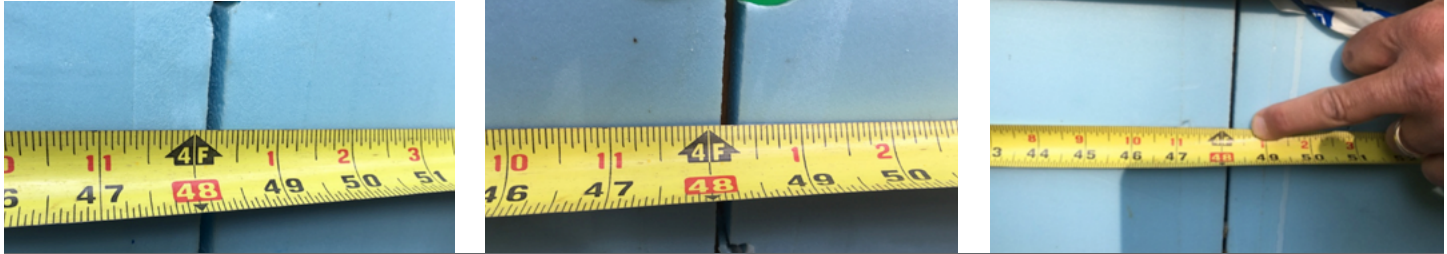
Photo 8a, b, c; width dimension measurement of three boards with intact factory edges

Photos 8 a, b, c show the width dimension of the three exposed boards with intact factory edges. Each measured board is slightly over 48", which indicates that although slight gaps are present that the boards remain at the manufacturing design dimension, in fact slightly wider. The cap nail does not show signs of pull

through or sliding in the foam that could also indicate board movement. Again this is an indication that boards have not shrunk in the width dimension. It can be concluded from the combination of tape condition, lack of fastener drag and current board dimension that board gaps resulted from installation.

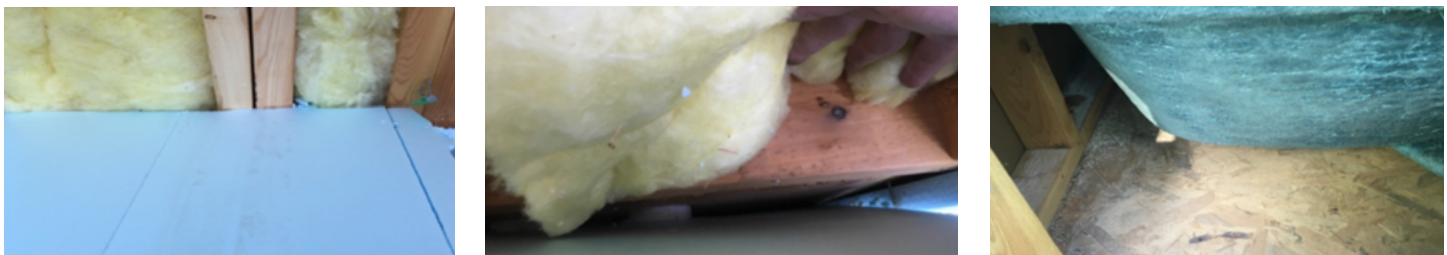
Photo 9a, back side of foam

Since no wood sheathing was used in construction of the wall system, it was possible to inspect cavity conditions for signs of deterioration and water intrusion. Photo 9a is of the back of one removed piece of STYROFOAM™ Brand Insulation and is found in clean condition with no signs of water anywhere on the board,

including around fasteners and board edges. Photos 9b and 9c show the conditions within the cavity including the bottom plate and subfloor below the bathtub located at the interior of the inspected cavity. Again, there are no signs of moisture or deterioration in either location.
