# DuPont global PV reliability

2019 Field analysis

# Executive summary

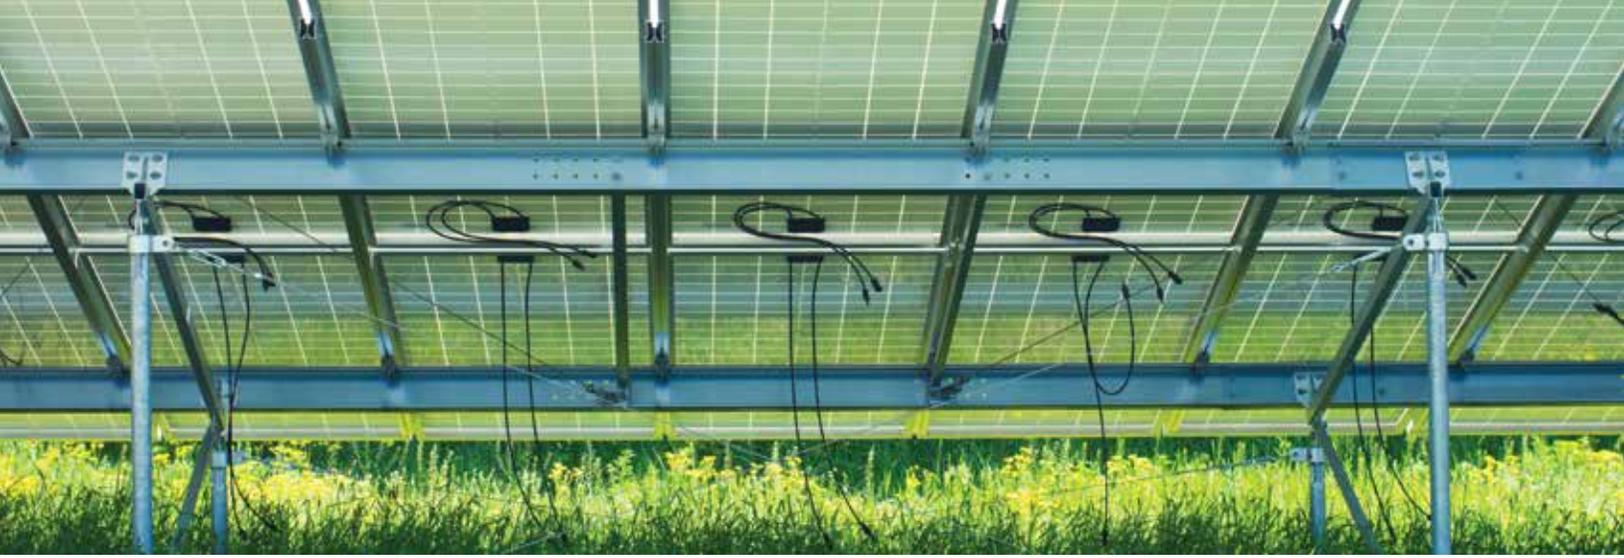
## PVDF backsheet failures

Outer-layer cracking

- Widespread cracks allow for delamination, directly exposing the core layer to the environment

Inner-layer yellowing

- Yellowing can be an early sign of material degradation and embrittlement

**Outer-layer cracks**  
6 years, NW China

**Outer-layer microcracks**  
2.5 years, Northern China

**Outer-layer cracks**  
7 years, SW USA

**Outer-layer cracks and delamination**  
6 years, Canada

**Inner-layer yellowing**  
6 years, SW USA

**Inner-layer yellowing**  
6 years, NW China

**Inner-layer yellowing**  
7.5 years, Italy

**Inner-layer yellowing**  
5 years, NW India

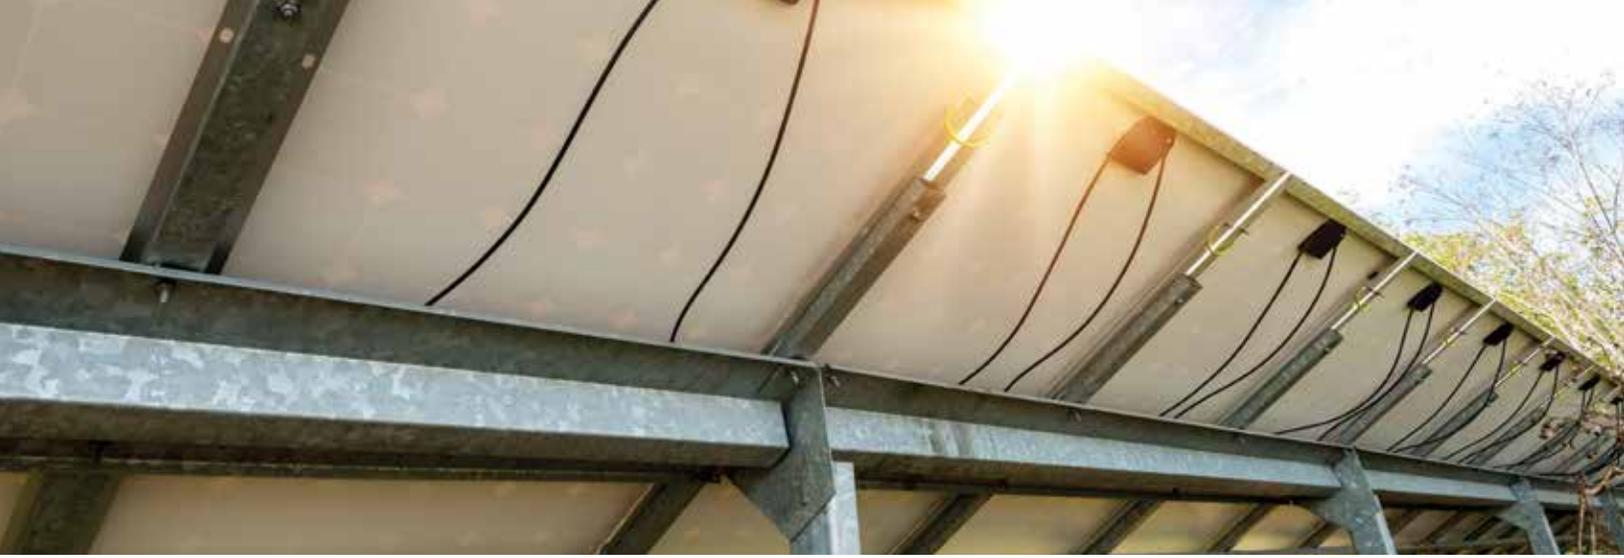
## Polyamide backsheet failures

Widespread backsheet through-cracks

- These failures are prevalent along busbar ribbons, but with continued weathering can extend to cell gaps and other regions
- Arcing and shorts often lead to localized burn-through and sometimes full module fires
- Reported inverter tripping and ground faults
- Over 12 GW of field failures to date

**Outer-layer cracks**  
6 years, NW China

**Inner-layer cracks**  
6 years,  
Sonoran Desert, USA

**Burn-through**  
7 years,  
Sonoran Desert, USA

**Burn-through**  
6 years, High Desert,  
Nevada, USA

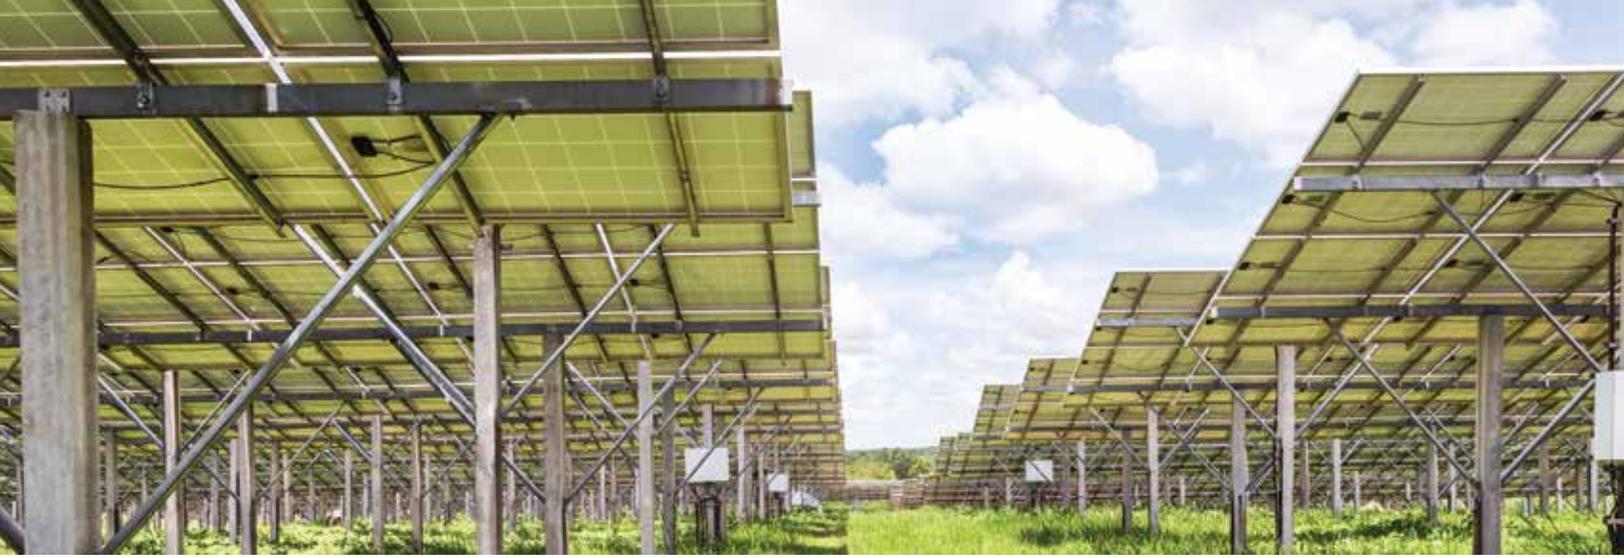
### **PET backsheet failures**

Inner- and outer-layer cracking

- Inner-layer cracks enable moisture to enter, often leading to busbar corrosion
- Outer-layer cracking exposes PET core to environmental degradation, also allowing moisture to enter
- Exposing module interiors to moisture can lead to shorting, inverter trips, power loss, and multiple module fires

**Inner-layer cracking**

7 years, Sonoran Desert, Arizona, USA

**Outer -layer cracking**

8 years, Arizona, USA

**Outer-layer cracking**

6 years, NW China

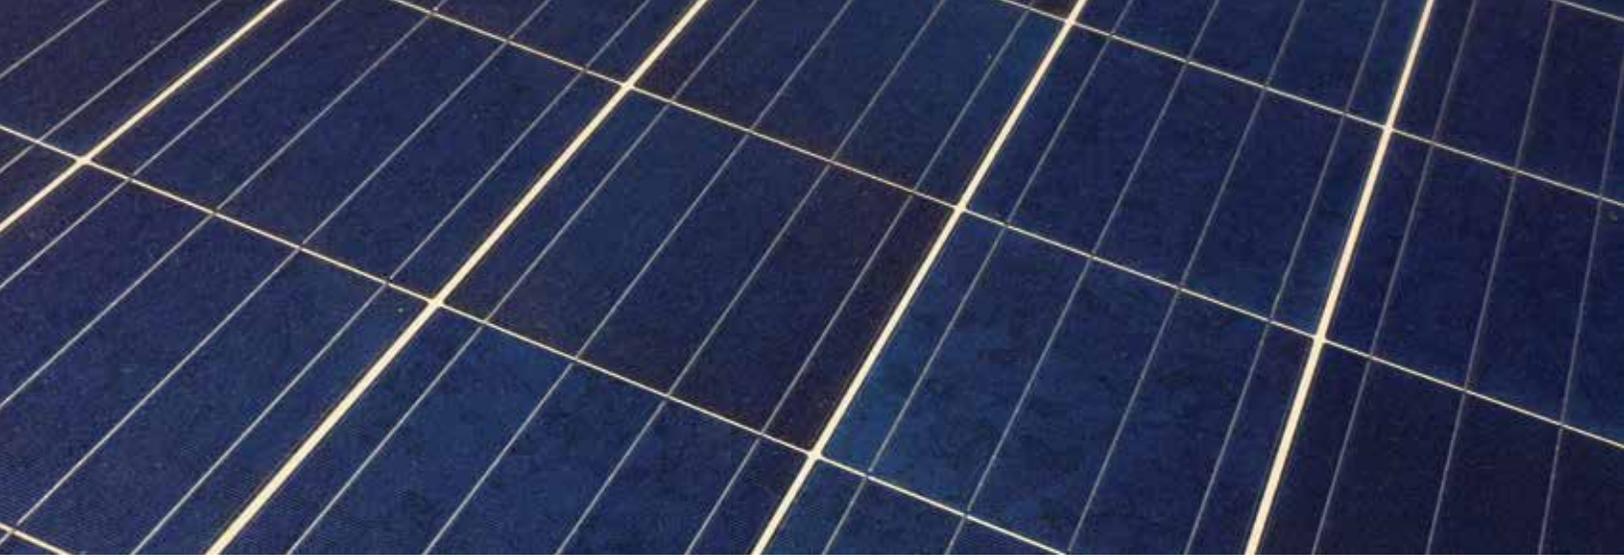
## Glass – glass module failures

### Delamination and cracking

- Delamination appears to originate near edges of a module or at individual cells
- Cracks likely originate at scratches or chips on the glass surfaces and edges or at stress risers introduced by the racking system

**Glass/encapsulant delamination**  
1.5 years, Northern China

**Encapsulant delamination**  
10 years, Arizona, USA

**Delamination and corrosion**  
15 years, Southern China

**Delamination**  
20+ years, Italy

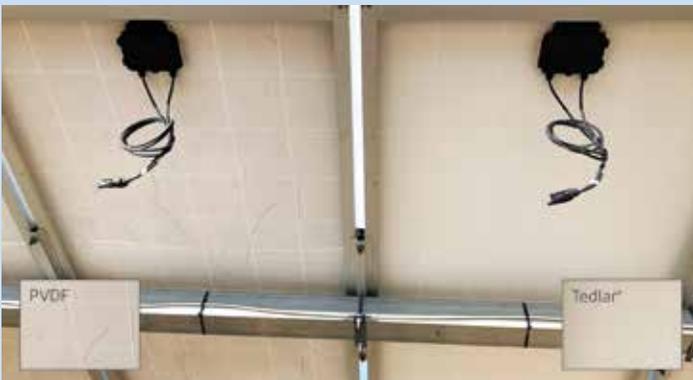
A large independent power producer (IPP) in Arizona discovered one of their sites was producing less energy than predicted. Upon reviewing the system for failures, they found certain backsheets had started to crack and delaminate – leading to high leakage currents tripping inverters and causing partial shutdowns and late starts.

DuPont inspected the 7-year-old site through its Fielded Module Inspection Program and discovered widespread backsheet cracking and delamination on many of the modules. While the site was composed of modules from a single manufacturer and model, as many as three different backsheet types were identified, suggesting the module manufacturer used multiple bills of materials (BoMs) for the same project.

- **100% of PA backsheets exhibited cracking along busbar ribbons**
- **100% of PET backsheets exhibited inner-layer cracking**
- **100% of PVDF backsheets exhibited outer-layer cracking**
- **0 defects in Tedlar® PVF backsheets**
