# Mitigating Strategies for Hot Spots in Crystalline Silicon Solar Panels

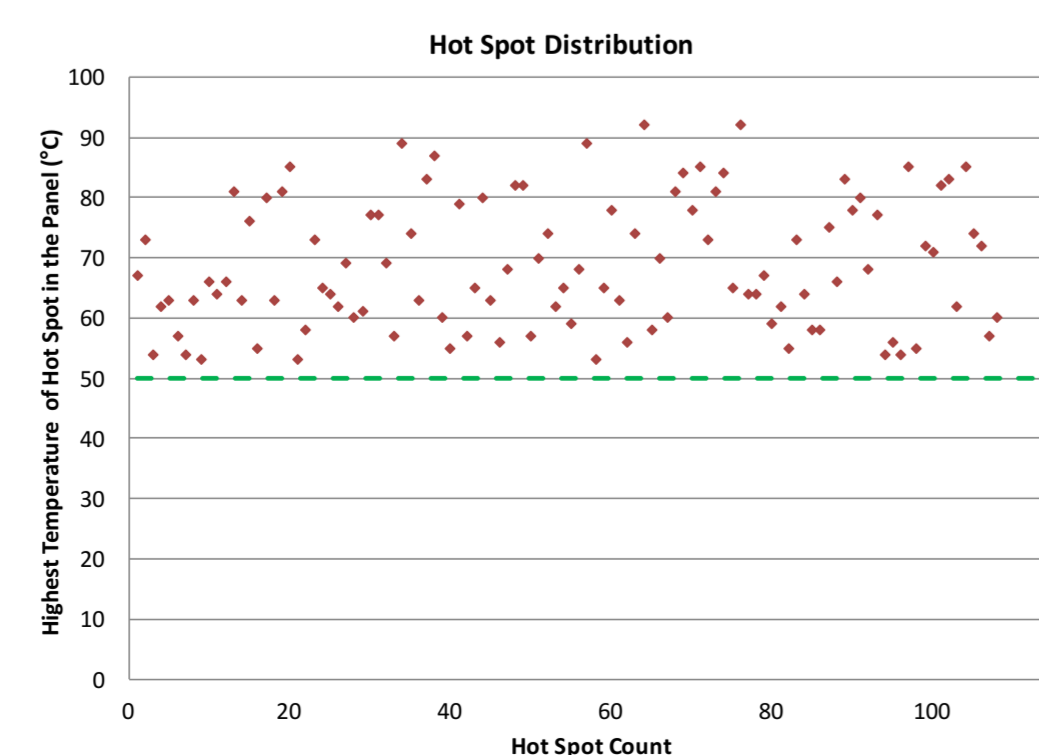
Distribution of hot spots following a sand storm. Operating state prior to cleaning. A total of 2,040 panels surveyed.

A survey of the impact of sand buildup on hot spots following a sand storm on 2,000 panels showed that 1.7% of the panels had hot spots of 10°C to 20°C above normal operating temperature and 2.2% of the panels featured hot spots of more than 20°C above the normal operating temperature.

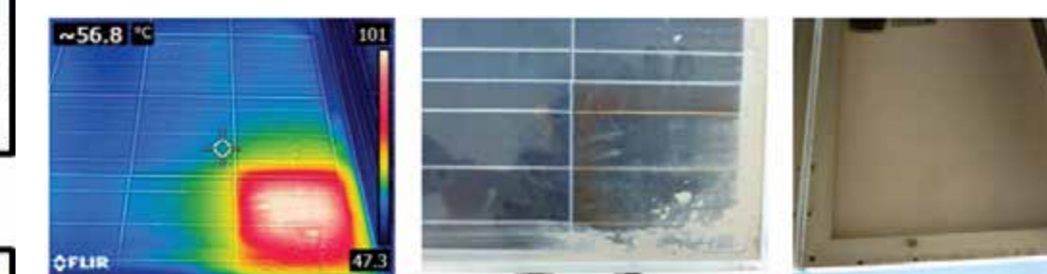
Partial shading of the cell by sand created a hot spot condition reaching 100°C (50°C above normal operating temperatures). The PVF-based backsheet suffered no damage and normal operation resumed upon cleaning.

Examples of damaged backsheets due to hot spots are shown below. A tri-layer backsheet composed of PVF/polyester/PVF presents an advantage over other backsheet constructions, in particular in partial shading conditions.

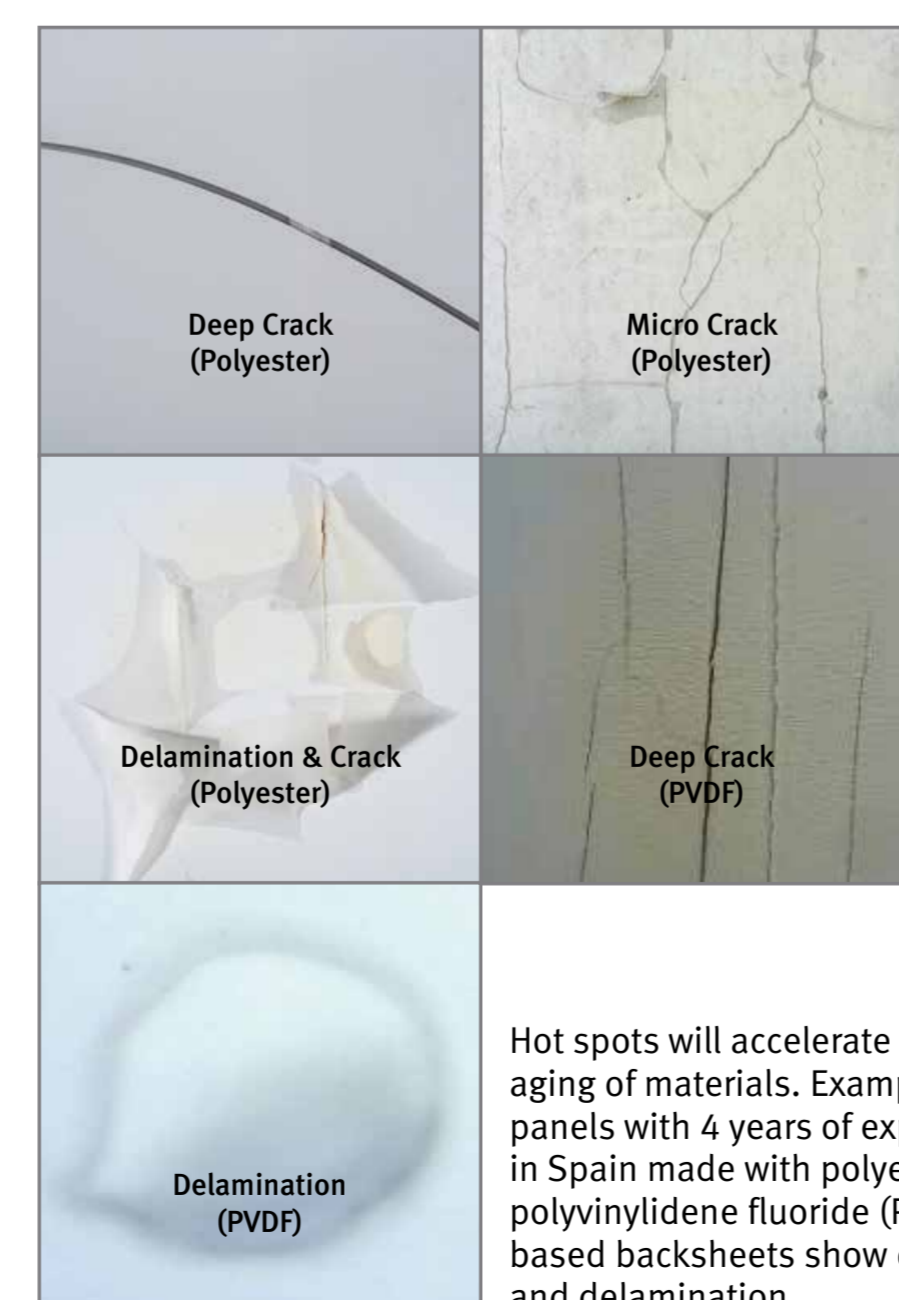
Hot spots will accelerate the aging of materials. Examples of panels with 4 years of exposure in Spain made with polyester and polyvinylidene fluoride (PVDF)-based backsheets show cracking and delamination.

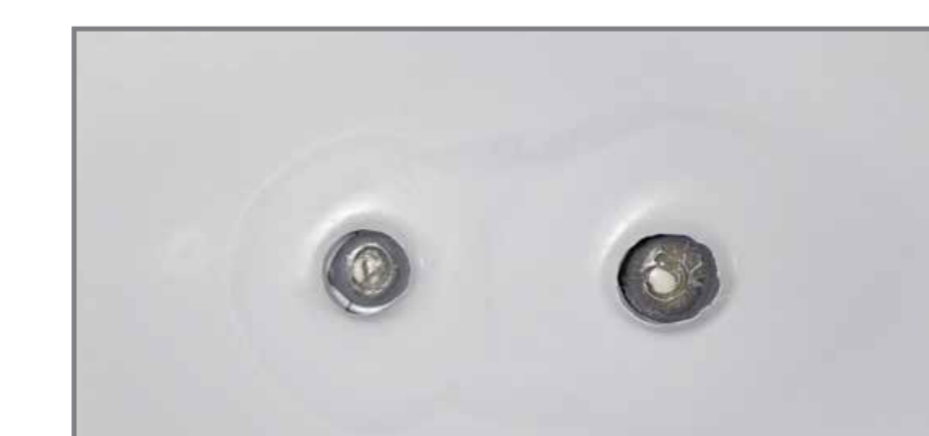
Bubbling leads to cracking

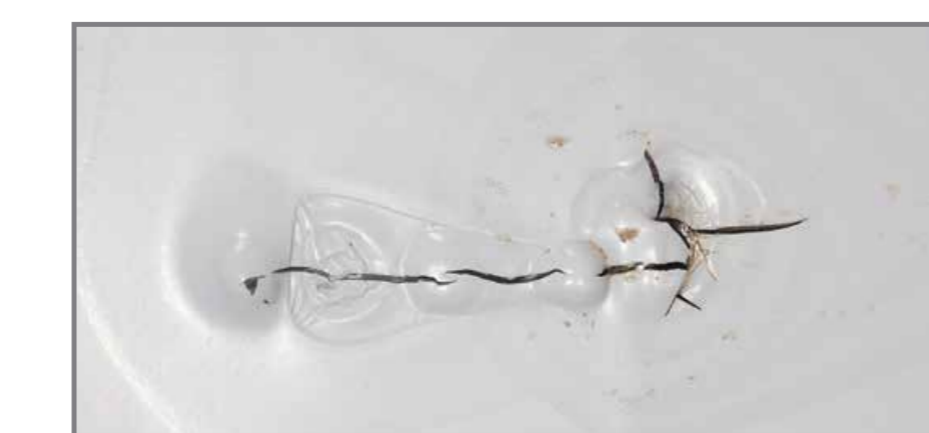
High intensity hot spots in PVDF-based backsheets

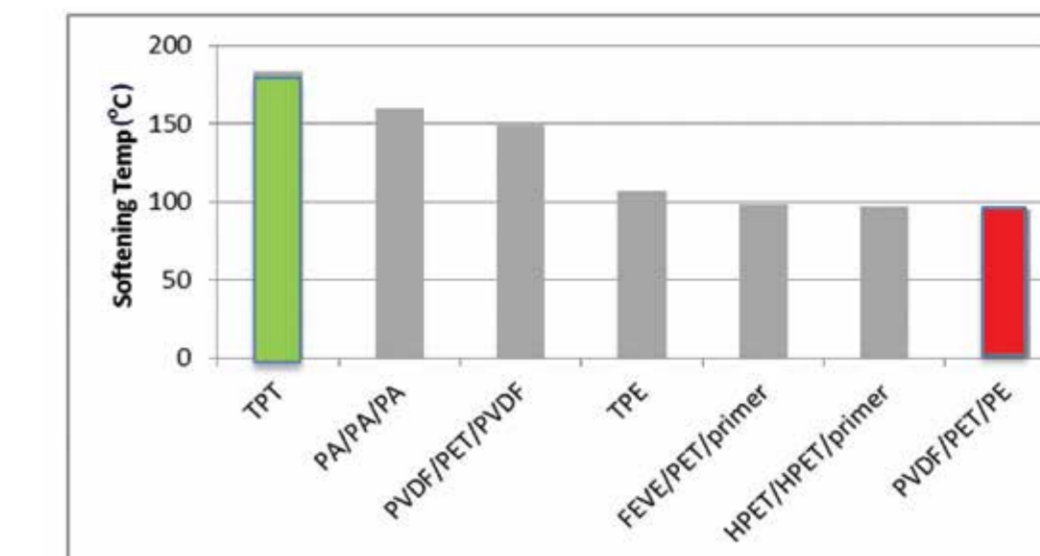
JIS K7196 Heat Deformation Test—weighted stylus impinges on sample being heated, thermal transitions noted.  
TPT: Tedlar® PVF/PET/Tedlar® PVF; TPE: Tedlar® PVF/PET/primer

In addition to the acceleration of the aging mechanisms, the temperature resistance of the inner layer (the layer in the backsheet which ensures durable adhesion to the encapsulant) is a factor of prime importance in retaining the adhesion of the insulation layer to the EVA at the back of the panels.

- Tedlar®/PET/Tedlar® or TPT backsheet has Tedlar® PVF as an adhesion layer. This material exhibits the highest temperature resistance of all the backsheets studied here while providing optimum UV and moisture resistance.
- Polyvinylidene fluoride (PVDF) backsheets exhibit varying degrees of temperature resistance according to the formulation and manufacturer of the PVDF. Therefore, this material exhibits variable properties that can impact its suitability for the field.

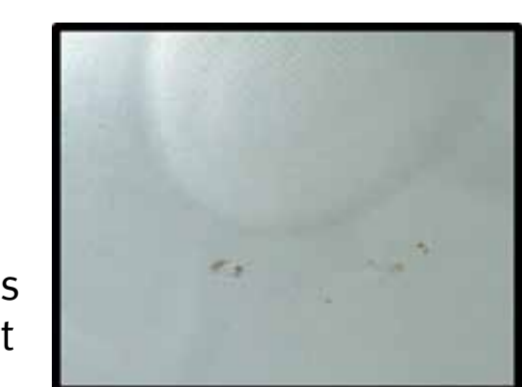
Delamination of PVDF-based backsheet on 134°C hot spot.

In this example, we dismantled the junction box to examine the interior. We found visually undamaged bypass diodes; however, the diodes were unable to prevent the hot spot that damaged the backsheet. In this case, the bypass was not triggered, showing either that the diode did not function as expected or that the diode had not reached the designed reverse bias for operation. In all cases, the non-operation of the bypass should be considered as a failure.

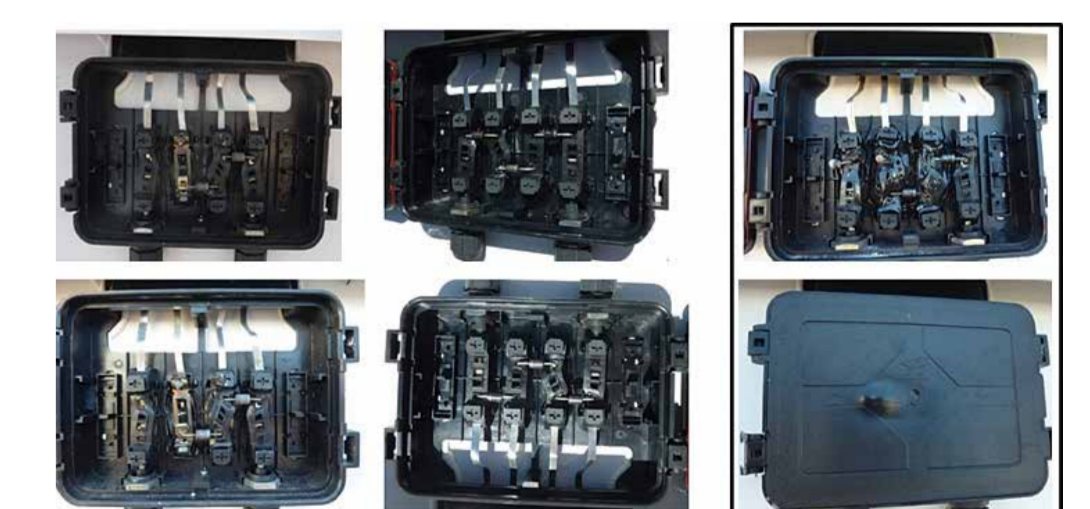
Example of bypass diode overheating and subsequent junction box melting.

However, we have also encountered situations where although the bypass was triggered, it resulted in overheating of the diode and subsequent melting of the junction box. This shifts the safety risk from the backsheet to the junction box with increased risk of fire damage coming from burning of thermoplastic materials.
