DOCUMENTING ENERGY EFFICIENCY: FROM DESIGN, TO CONSTRUCTION, TO OCCUPANCY

This case study for Ramona Apartments building provides a comparison between the designed parameters and the actual energy use, after the building was completed and occupied. The reason this case study is exceptional is because energy efficient design does not guarantee performance in use, and that the actual performance is rarely documented. Achieving energy efficient and sustainable buildings requires commitment all the way through the value chain of a building design and construction. It starts with a committed owner and investor, it continues with an energy efficient design and quality craftsmanship during the construction, and results in tangible dollar savings for the building occupants. One such example is Ramona Apartments, a 138-unit family-friendly building in the Pearl District, in Portland, Oregon, home to 133 children (and a total of 361 residents). The construction started in December of 2009 and was completed in March of 2011. What is remarkable about Ramona Apartments was, not only that the building was designed and built as energy efficient, but also that the performance has been validated a

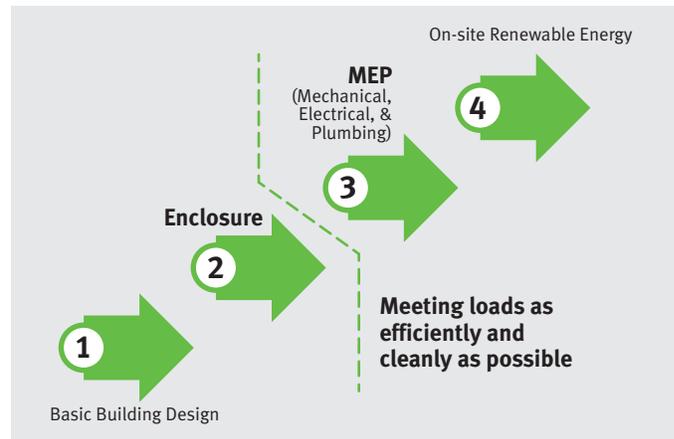
Figure 1. Energy Efficient Design Strategies for Ramona Apartments (Courtesy Walsh Construction Co.)

CommercialWrap® continuous air barrier. At the time Ramona Apartments were designed, Oregon energy code required compliance with ASHRAE 90.1 2007 which did not even include a mandatory air barrier requirement. The continuous air barrier requirement was firstly introduced by ASHRAE 90.1 2010, so, from the start the design team went beyond minimum code requirements. Design strategies for energy efficiency are summarized in Figure 1.

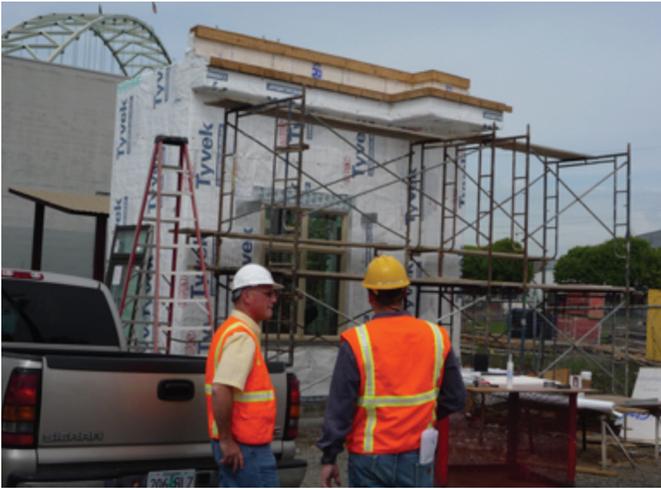
Figure 2. Mock-up wall assembly for Ramona Apartments Roland Carson (left), the Commercial Tyvek® Specialist with Orepac was at the site during mock up demo

During construction, all design features were carefully implemented. Walsh Construction Co. built a mock-up wall, and the entire design and construction team, including the owner, participated in the mock up demonstration using DuPont™ Tyvek® CommercialWrap® as a *continuous air barrier* (Figure 2). DuPont Technical Team and Commercial Tyvek® Specialist were involved with the design and construction team throughout the construction process. Figure 3 shows DuPont™ Tyvek® CommercialWrap® continuous air barrier being installed over gypsum board exterior sheathing. During construction, special attention was given to achieving continuity of the air barriers at the window-wall interface, transitions and penetrations.

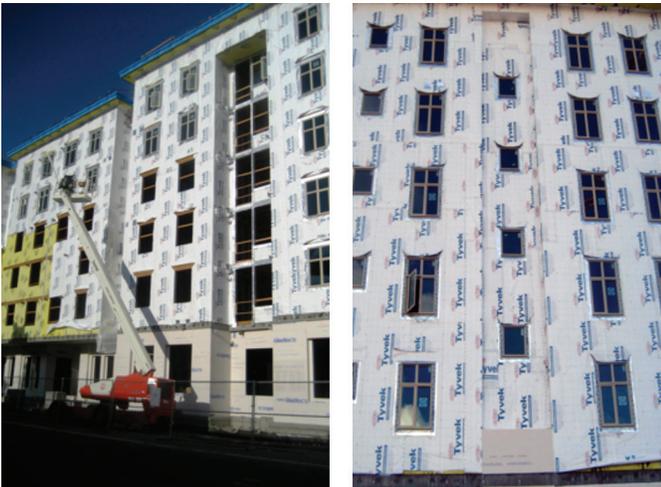
Figure 3. The Ramona Apartment: DuPont™ Tyvek® CommercialWrap® air Barrier was installed over the exterior gypsum board sheathing, with mechanical fasteners.

- **Wall design:** 2x6 wood-framed wall with brick cladding with 1” airspace.
- **Air Barrier system:** DuPont™ Tyvek® CommercialWrap® continuous air barrier was installed over gypsum board exterior sheathing. The wall air barrier tied into the roof membrane.
- **Exterior Walls Insulation:** Blown-in fiberglass wall cavity insulation rated at R-23 at upper 5 floors.

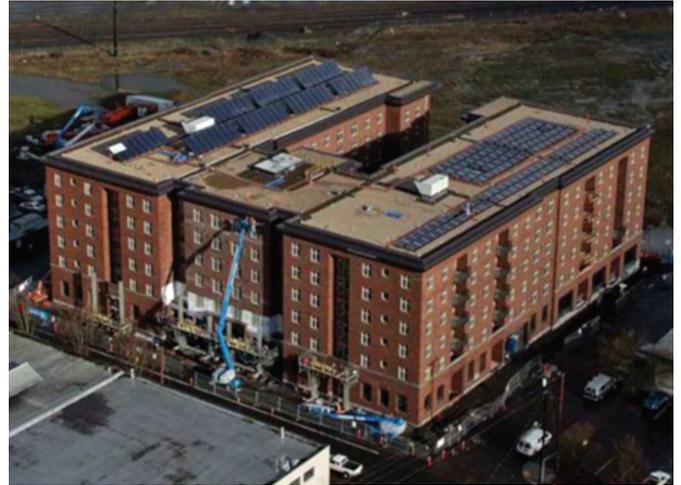
Figure 4. The Ramona Apartments: Brick veneer was installed as exterior cladding.

After detailing the continuity of Tyvek® air barrier system, brick veneer was installed as exterior cladding, as shown in Figure 4. Figure 4 also shows other energy efficient features such as PV panels on the roof for on-site generation of renewable energy.

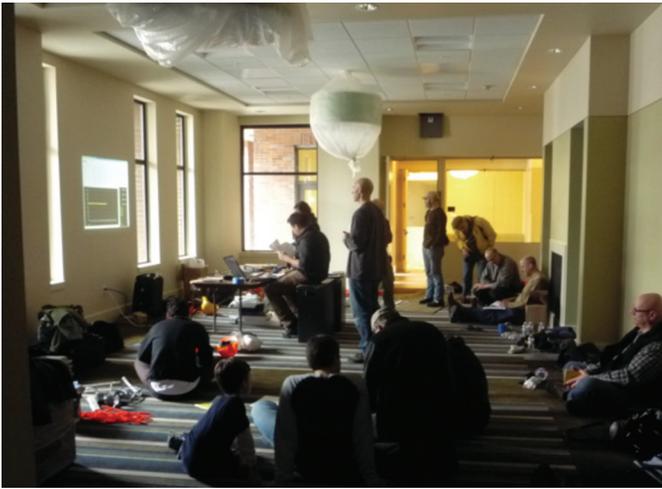
Figure 5. Whole Building Airtightness Testing – Watching the data collection.

During the Ramona Apartment's day-long testing, the team conducted building depressurization and pressurization with continuous data collection. The fans throughout the building were turned on, one by one, in order to slowly increase or decrease the building pressure to the required 75 Pa. The fans were controlled through a computer software program (Teclog2) so that single zone conditions were maintained for the entire exterior envelope. Throughout this period, the building was allowed to stabilize at benchmark pressures, and data were collected every minute. There was an extended team watching the test, comprised of those responsible for running the tests, the project team as well as test observers (Figure 5; a complete list of participants at the test is included in Appendix 1).

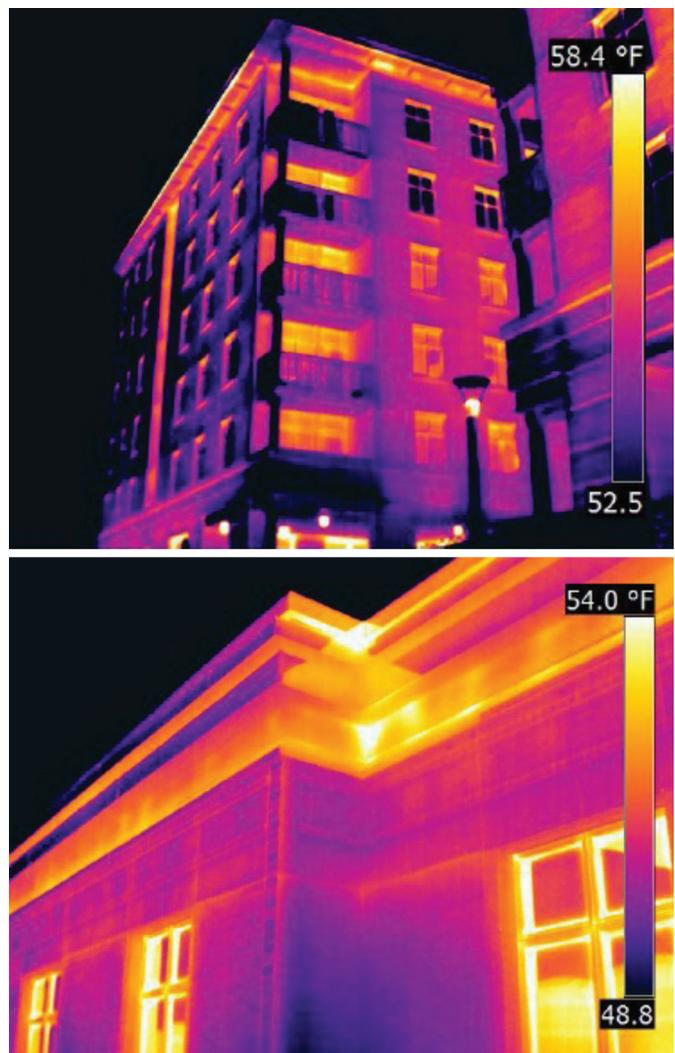
Figure 6. Thermal infrared pictures showing air leakage around the perimeter of the building (compliments of Mike Williams)

Thermal infrared and smoke detection were used to identify potential areas of further improvement in airtightness. The primary envelope issue noted was the seal at the roof-wall-soffit connection around the perimeter of the building. Additionally, air leakage was noticed at the attic ceiling level. None of these leakage sites are due to the imperfections of the wall air barrier, but rather the interface between the wall and the roof which is often difficult to detail. The IR imagery in Figure 6 clearly shows air leakage around the top perimeter of the wall-roof interface. The close up IR on the right shows the leakage into the soffit zone.

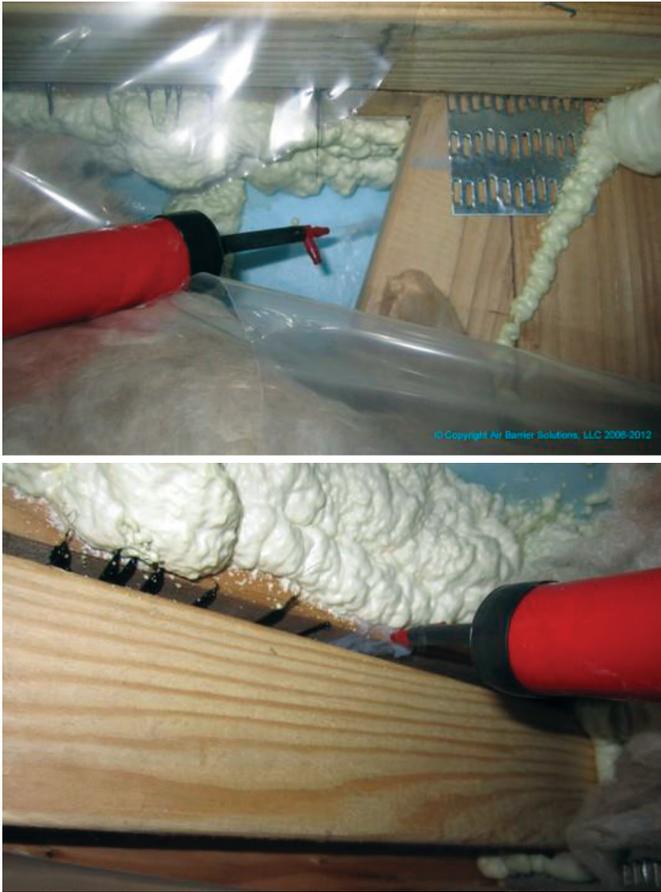
Figure 7. Use of tracer smoke to identify the location and severity of air leakage paths (Source: Ramona Apartments Building Envelope Inspection Report)

An air leakage detail at the attic ceiling level is shown in Figure 7. On the top, the friction fit insulation board was sealed top and bottom per the specs, but it leaks at the vertical truss connections. On the bottom, another leak near the air sealing work is evident. This pathway was probably missed because the installers lacked a fundamental understanding of air sealing and leakage pathways.
