# Tedlar®

## Zero Maintenance Over 42 Years: Nippon Steel on the Coast

A Nippon Steel factory around one kilometer from the ocean in Japan faces relentless salt spray, humidity, and industrial pollutants—but it has been well protected from these exposures by DuPont™ Tedlar® PVF film.

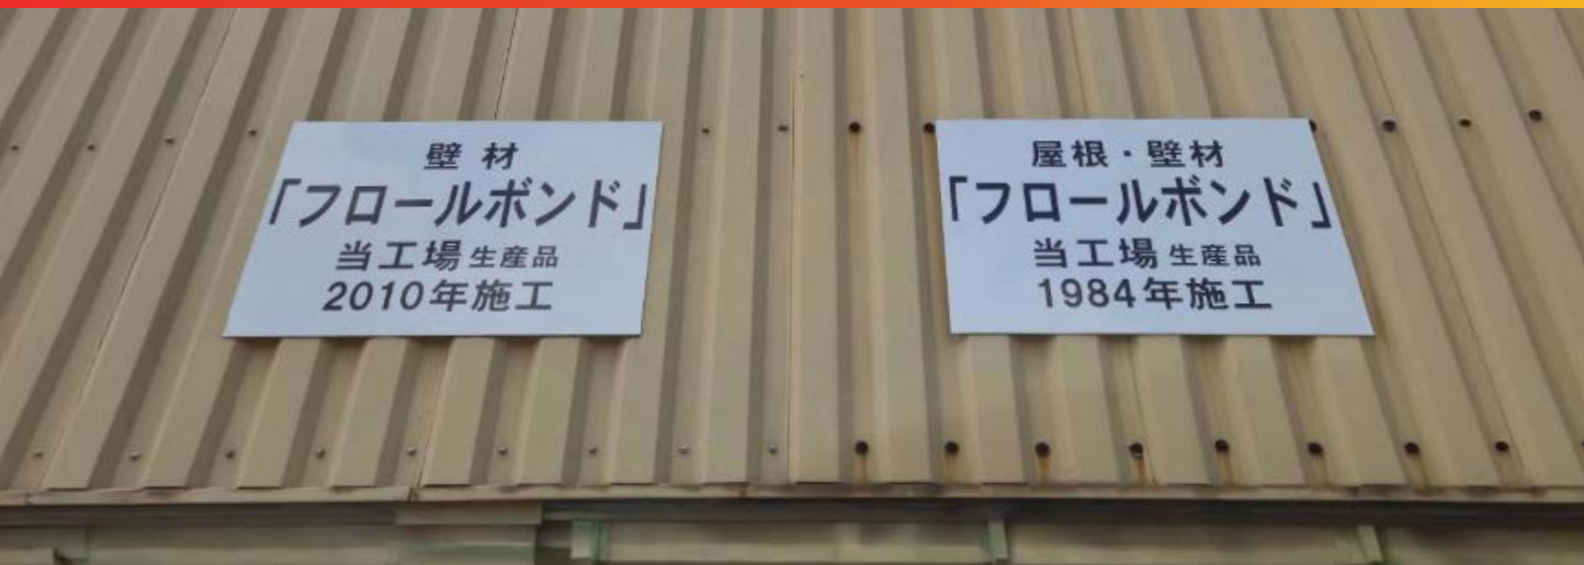
**Initially installed to safeguard the exterior in 1984 (phase one, galvanized steel) and 2010 (phase two, ZAM self-healing advanced steel), the metal siding panels continue to look unaged and unchanged as of July 2026.**

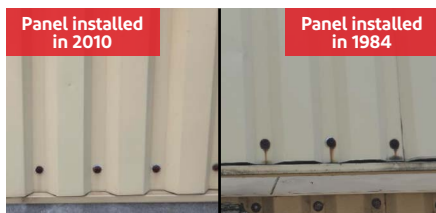
#### Corrosion Resistance

After enduring decades of coastal and industrial conditions, the steel bolts on the panels displayed visible corrosion and rust streaks. Meanwhile, the cut edges, typically the most vulnerable point of a panel, show no signs of corrosion on either side of the Tedlar® laminated facade.
