## Customer Success Story

# Subzero Operating Conditions Are No Match for FILMTEC™ Seawater Reverse Osmosis Elements

**Plants location:** Antarctic: Rothera & Signy Research Stations

**FILMTEC™ RO element:** SW30-4040

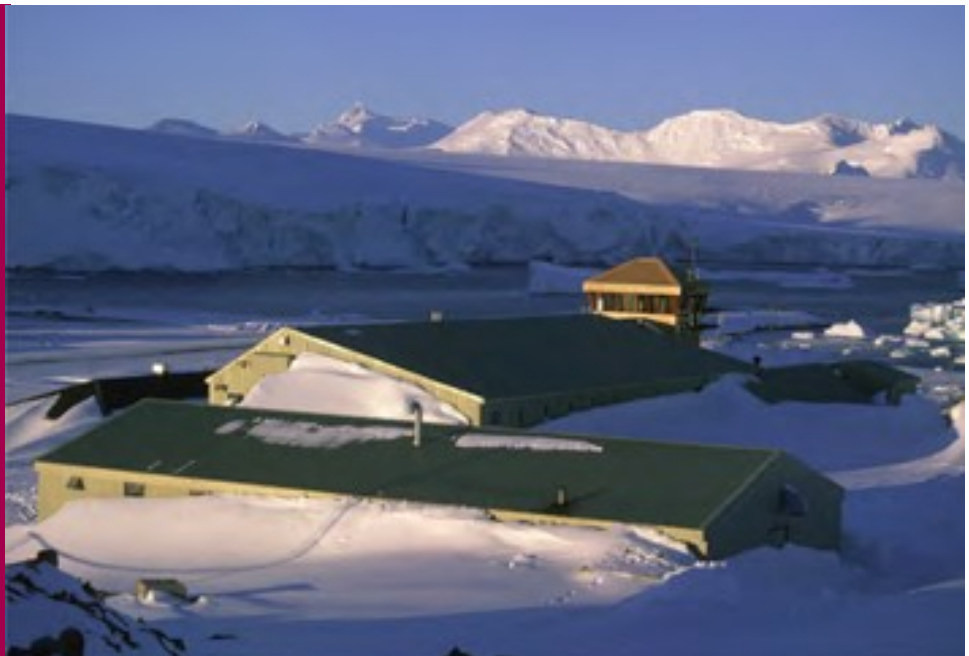
The Rothera unit, shown in Figure 1, and Signy unit consist of self-contained skid mounted plants, including: sand filter, cartridge filters, antiscalant dosing (Rothera only), a clean-in-place (CIP) system and rehardener.

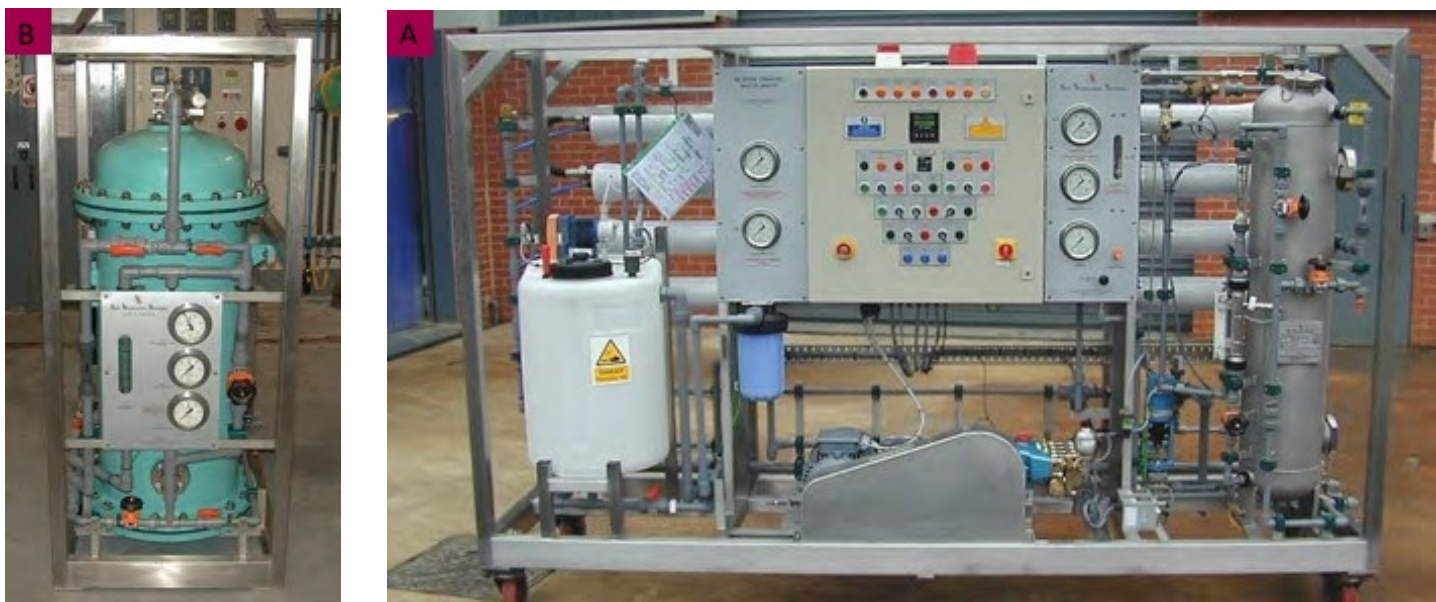
Figure 1: Images of Rothera plant (A. Sand filter and B. RO unit), courtesy of Salt Separation Services, UK.

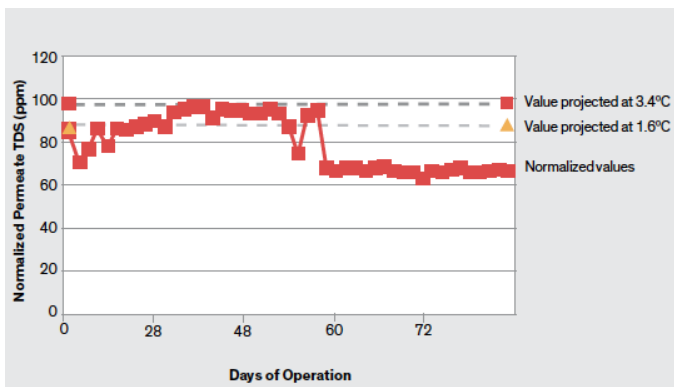
Figure 2: Normalized permeate TDS registered at Rothera plant.

In the first two and a half months of operation, the normalized salt rejection and permeate flow data was collected almost daily. During this time, the temperatures were between 3.4 and 1.6 °C, as shown in Figure 2 and Figure 3.

The values in Figure 2 are compared to a DuPont system design tool, Reverse Osmosis System Analysis (ROSA). The data values, equal or lower than the ROSA projected values, show excellent element performance.

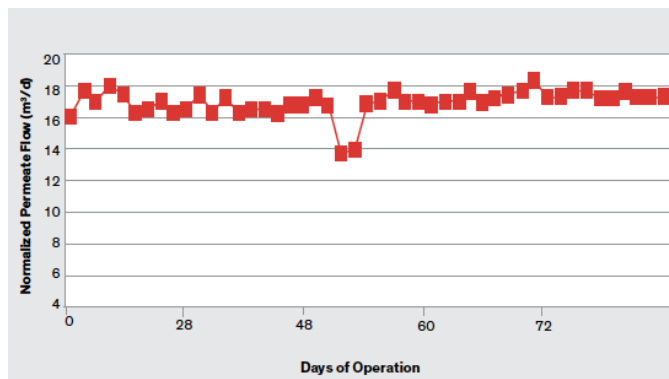
Figure 3: Normalized permeate flow registered at Rothera plant.

The normalized permeate flow remained very stable during the data collection timeframe, indicating no effect of long term low temperature operation.
