Dow Building & Construction

Case Study:

STYROFOAM™ Brand Insulation: Shrinkage Case Studies

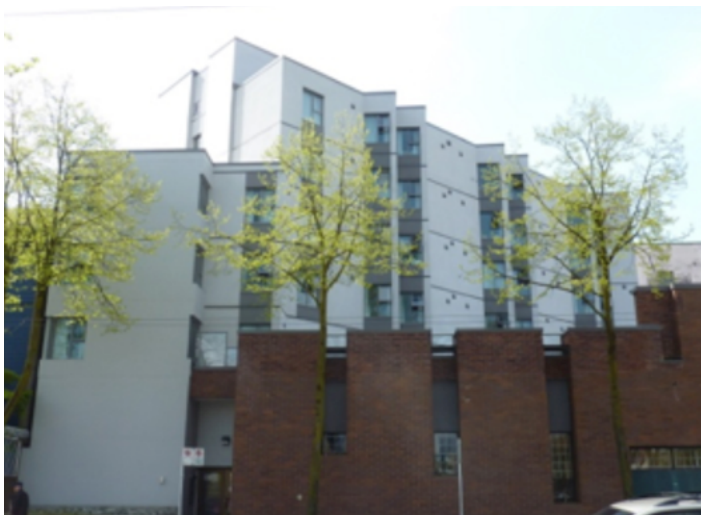
Photo 5a
North Elevation After Repairs

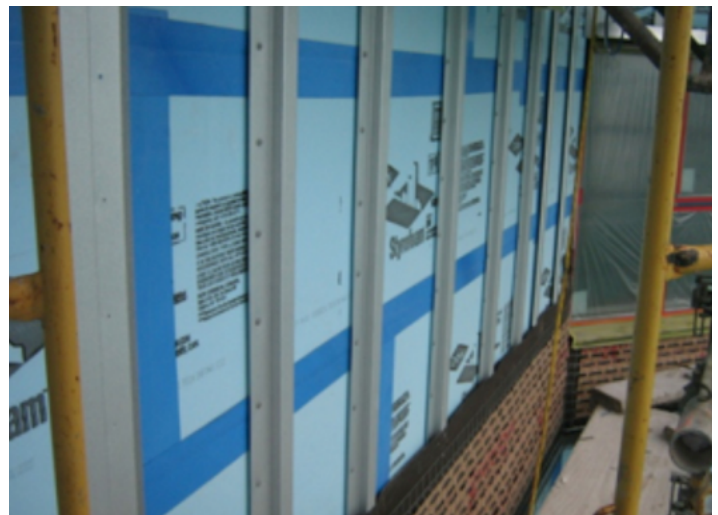
The new wall assembly includes three inches of STYROFOAM™ Brand insulation with a nominal R-value of R15. The rain screen cavity is achieved by fastening the paperback lath on the outside face of the metal Z girt over which a three coat stucco is traditionally applied.

Photo 5b
Galvalume Z-girts on 3" rigid XPS

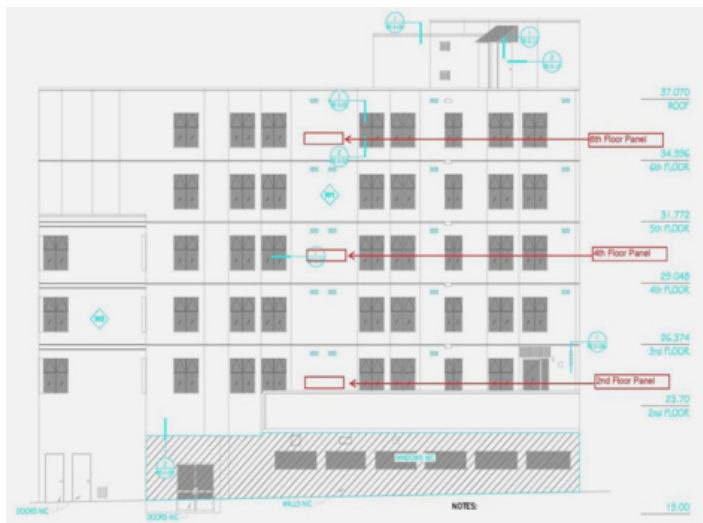
Building position measurements were taken on the south and north façades of the building, with sensors located on the second, fourth and sixth floors. Locations of measurement panels are indicated by the red squares in Figure 1 for the south location. North instruments were similarly located directly across the building.

Figure 1, Measurement Panel Locations (S)
