## Customer Success Story

# Subzero Operating Conditions Are No Match for FILMTEC™ Seawater Reverse Osmosis Elements

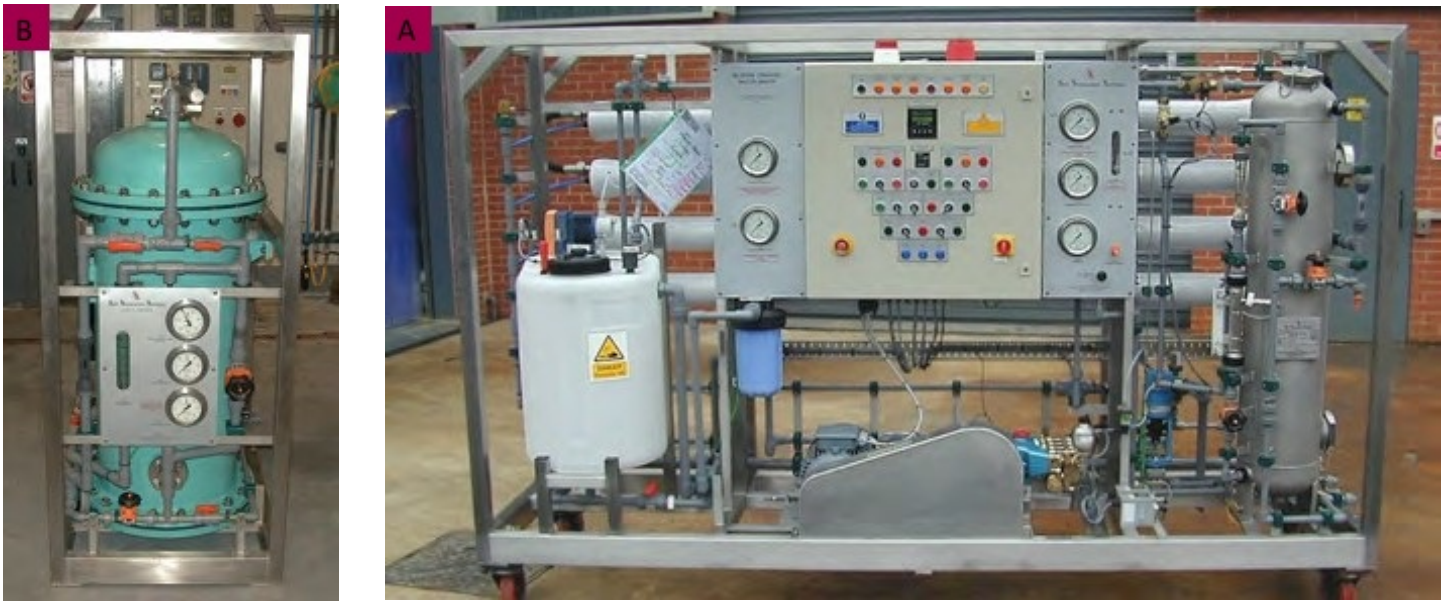
Figure 1: Images of Rothera plant (A. Sand filter and B. RO unit), courtesy of Salt Separation Services, UK.

The Rothera unit, shown in Figure 1, and Signy unit consist of self- contained skid mounted plants, including: sand filter, cartridge filters, antiscalant dosing (Rothera only), a clean-in-place (CIP) system and rehardener.

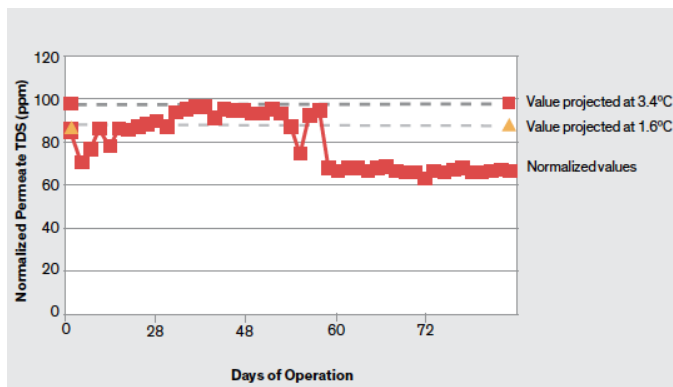
Figure 2: Normalized permeate TDS registered at Rothera plant.

In the first two and a half months of operation, the normalized salt rejection and permeate flow data was collected almost daily. During this time, the temperatures were between 3.4 and 1.6 °C, as shown in Figure 2 and Figure 3.

The values in Figure 2 are compared to a DuPont system design tool, Reverse Osmosis System Analysis (ROSA). The data values, equal or lower than the ROSA projected values, show excellent element performance.

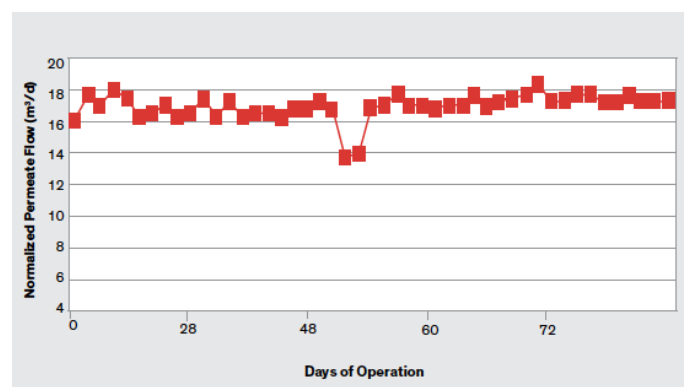
Figure 3: Normalized permeate flow registered at Rothera plant.

The normalized permeate flow remained very stable during the data collection timeframe, indicating no effect of long term low temperature operation.
